Orange Coast College Vision 2020 Facilities Master Plan Initial Study

Coast Community College District
1370 Adams Avenue
Costa Mesa, California 92626
Contact: Jerry Marchbank
Senior Director, Facilities, Planning and Construction

DUDEK
31878 Camino Capistrano #200
San Juan Capistrano, California 92675
Contact: Rachel Struglia, PhD, AICP

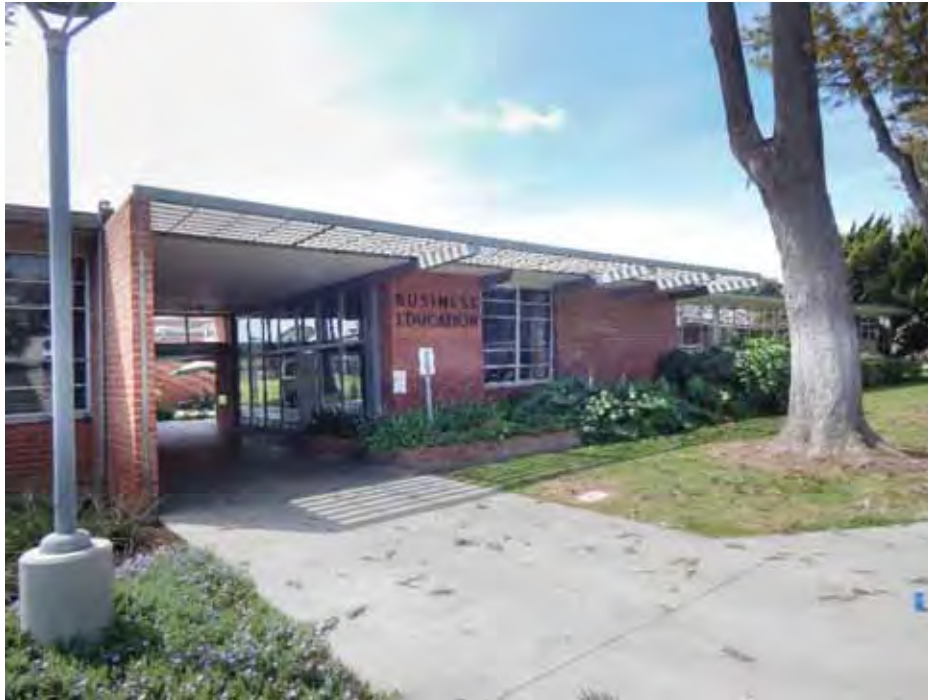
Figure 1B-24: Breezeway between Buildings 12 (left) and 13 (right) with shear walls added on north façade.

Seismic retrofitting completed in 1999 added plywood shear walls with brick cladding at the north façades of Buildings 12 and 13 (Figure 1B-24). Where inserted, the new walls typically replaced four bays of windows. Two small brick shear walls were also added to the south façade, where new tube columns were also added. HVAC equipment and ducts were added on top of the covered walkways of Buildings 12 and 13, possibly around 1986 when similar equipment was added to other buildings on campus.

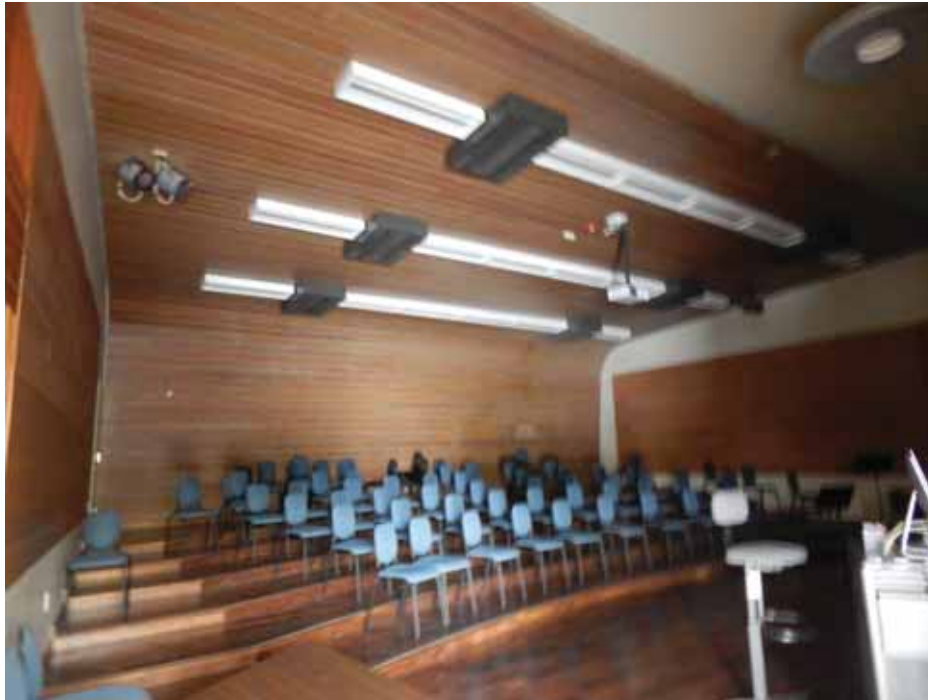
Figure 1C-60: Room 101 of Building 4 with original wood curved wall and ceiling.

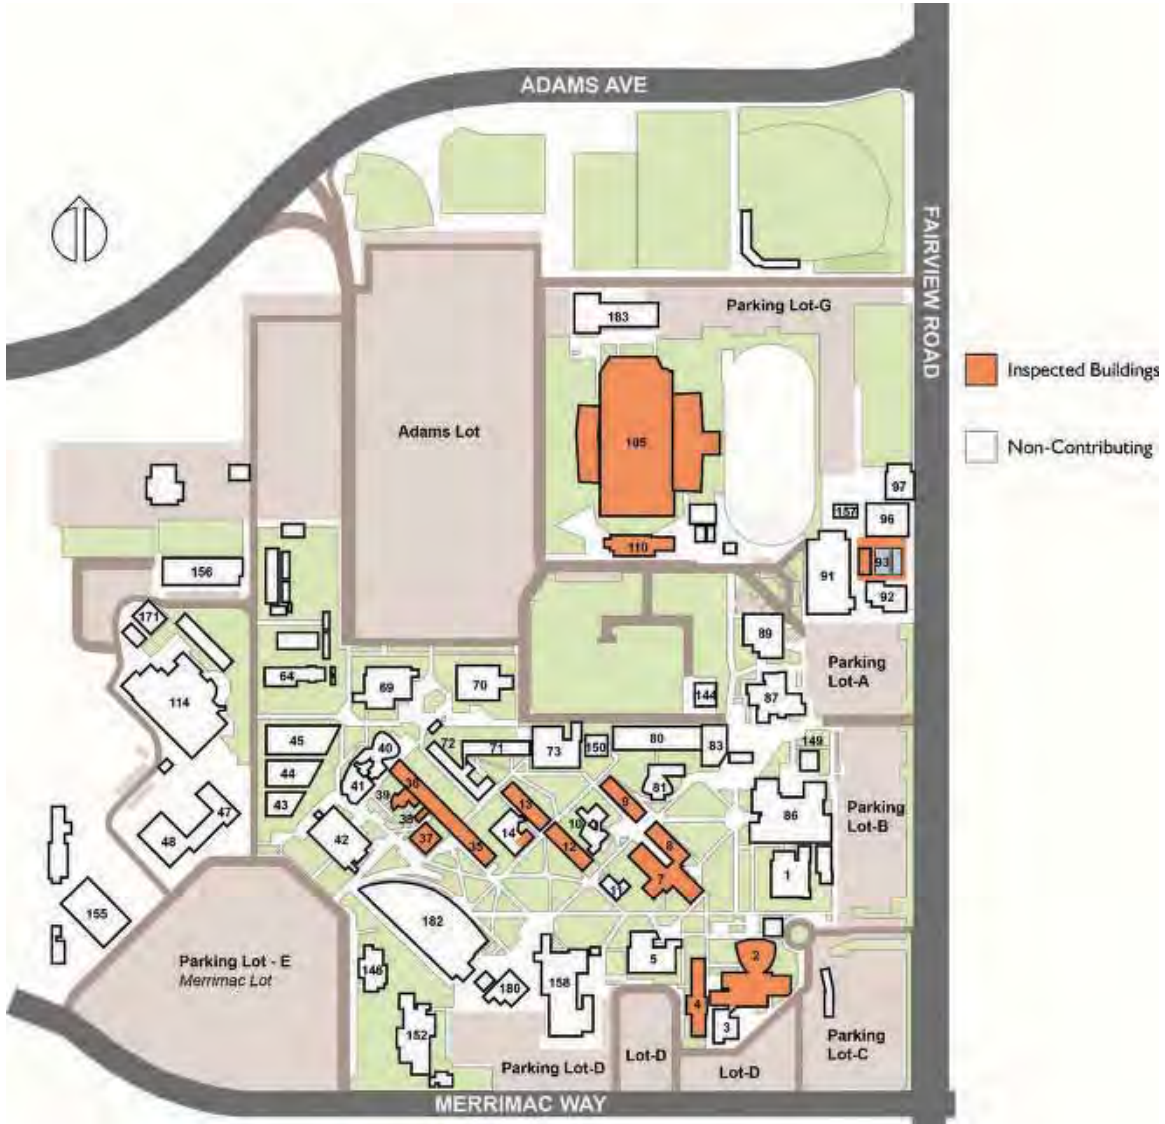
Figure 2: Campus map identifying the buildings that were included in the condition assessment (orange).

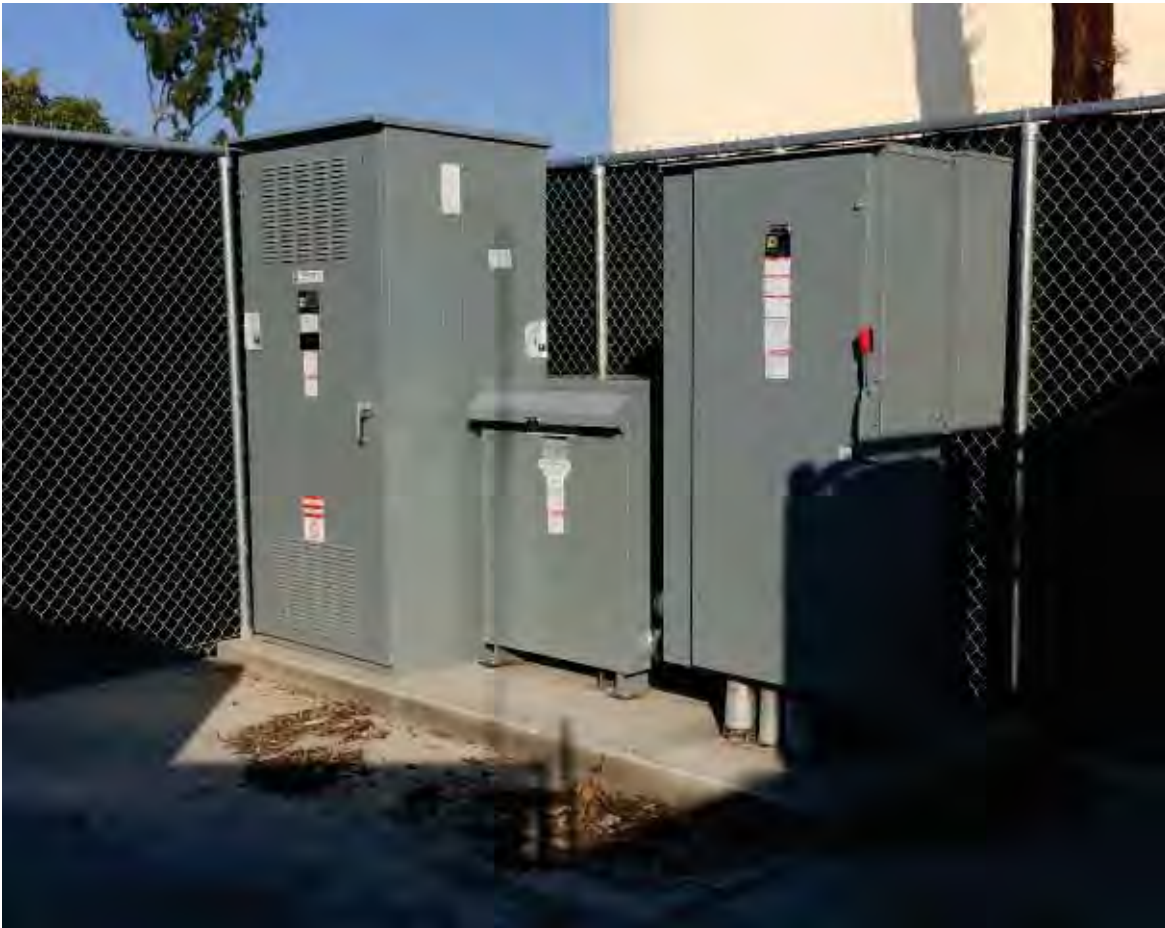
Exterior electrical yard between buildings 2 and 4 – 5kV switch, Transf. TVHM and Swbd STH

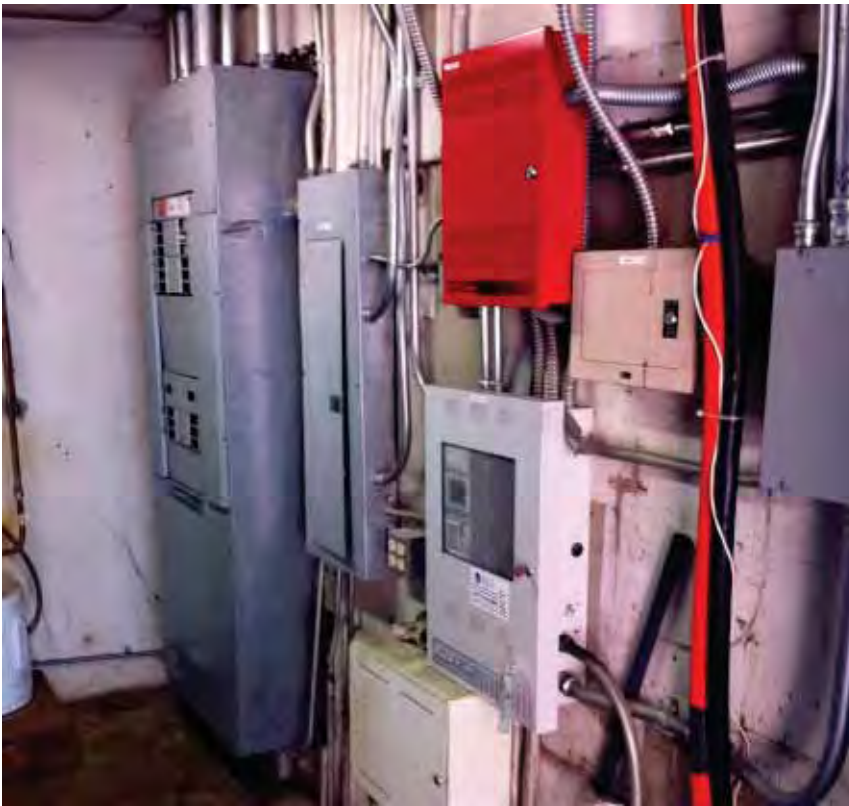
Building 7 Electrical Room – Water heater to left in front of Swbd

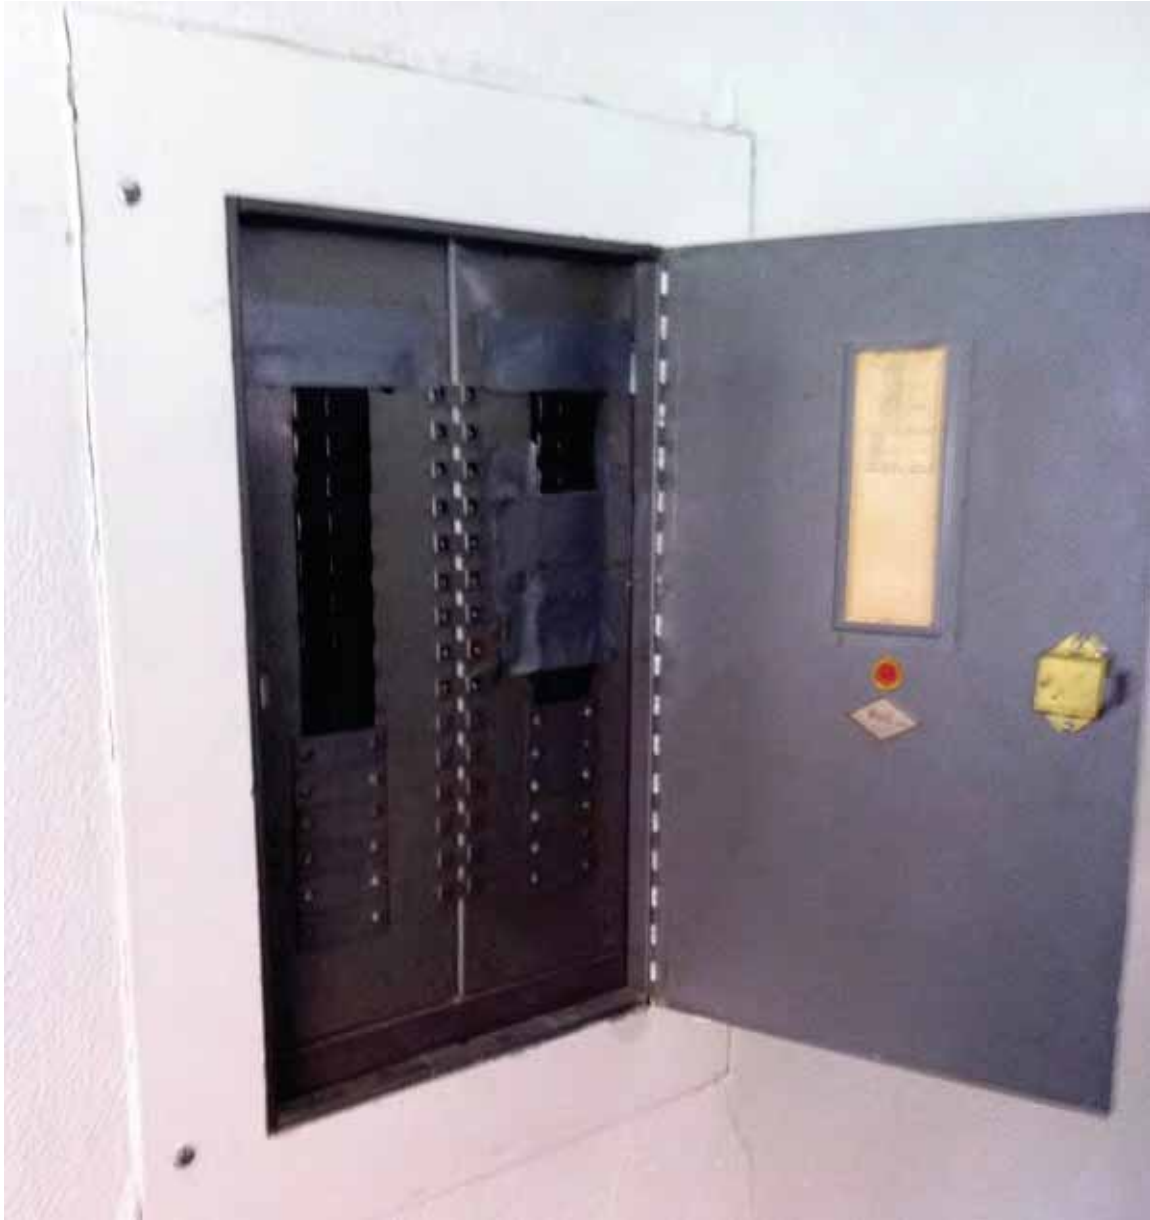
Existing Zinsco Panelboard Original to Building

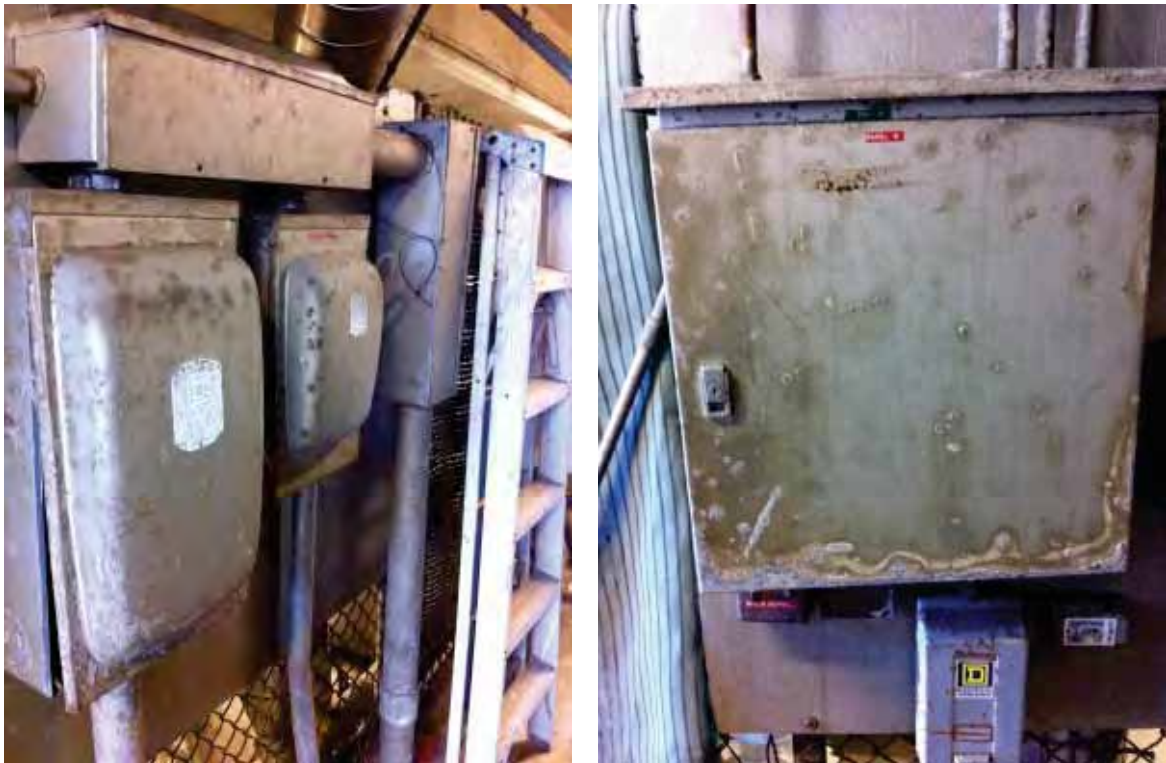
Existing electrical equipment and panelboard showing signs of corrosion

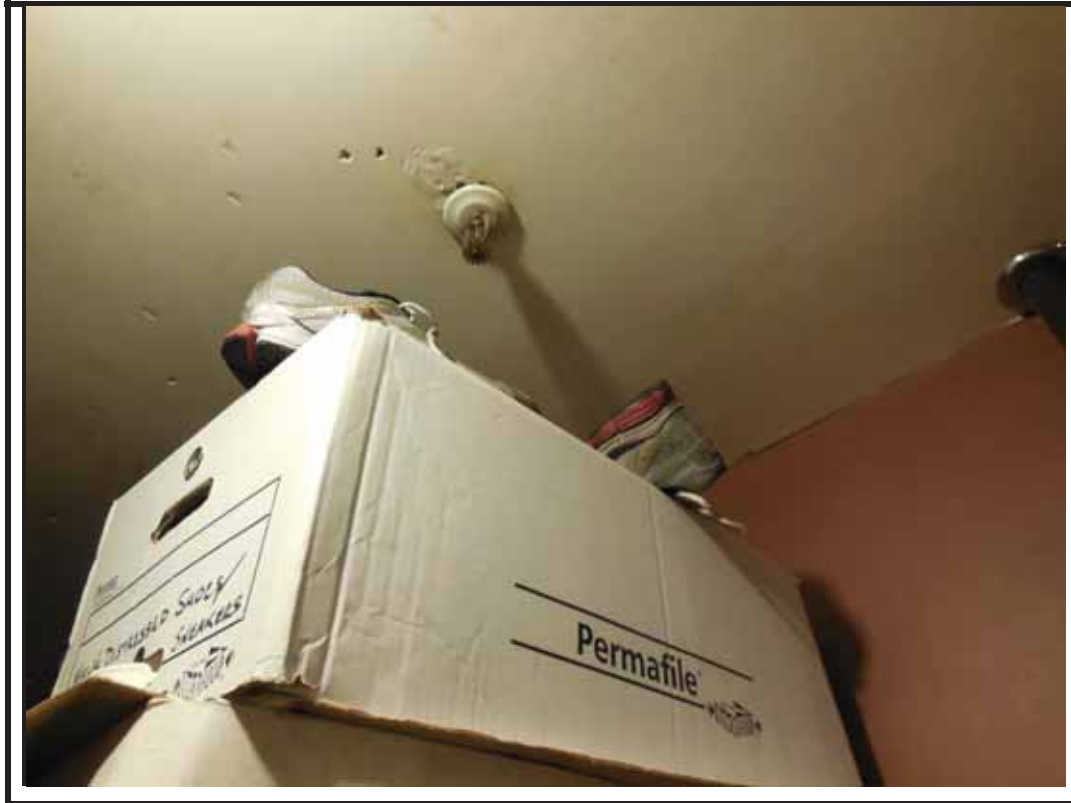
Photograph 1: Storage close to the sprinkler head in the fire sprinkler riser room in Building 2

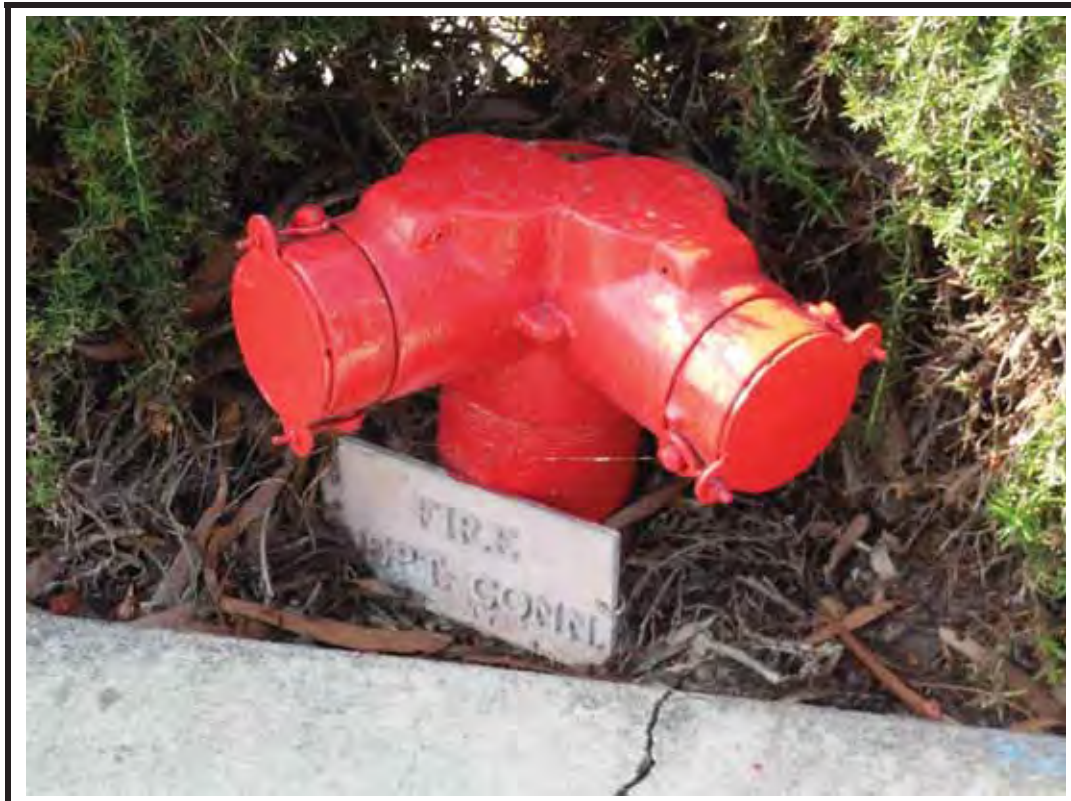
Photograph 4: FDC not identifying what buildings it serves. The picture also shows an improper cap on the FDC.

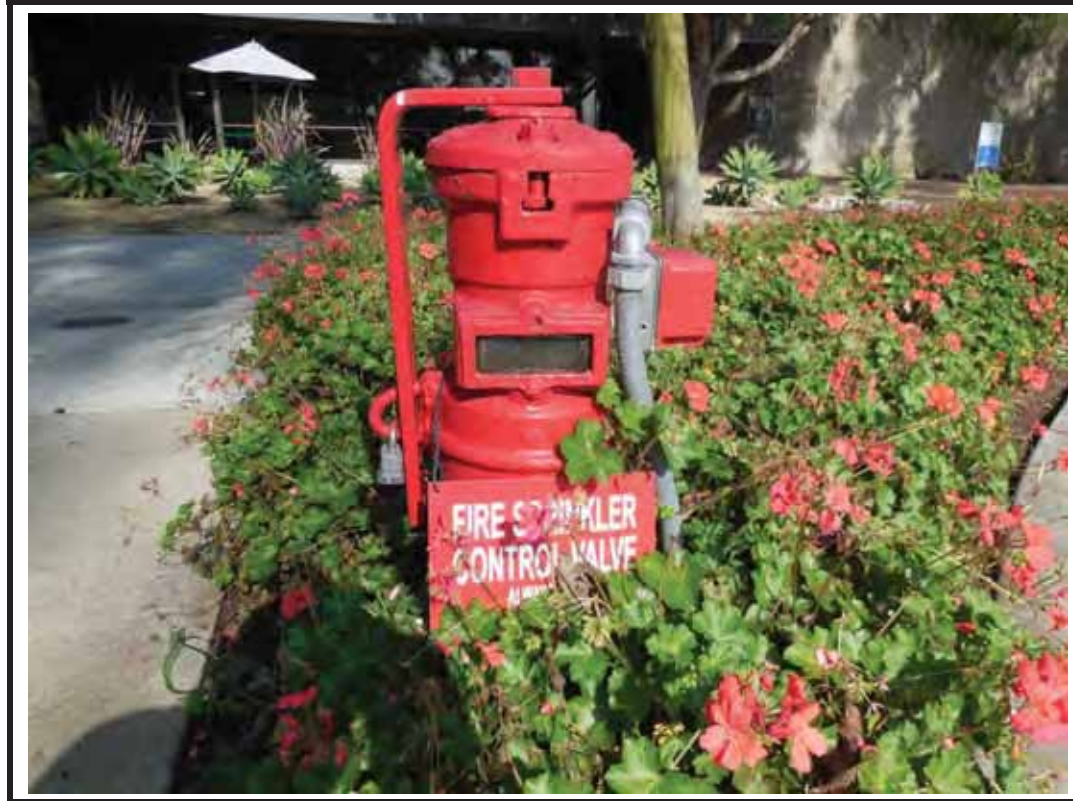
Photograph 5: Unable to read PIV to determine if the valve is open or closed.

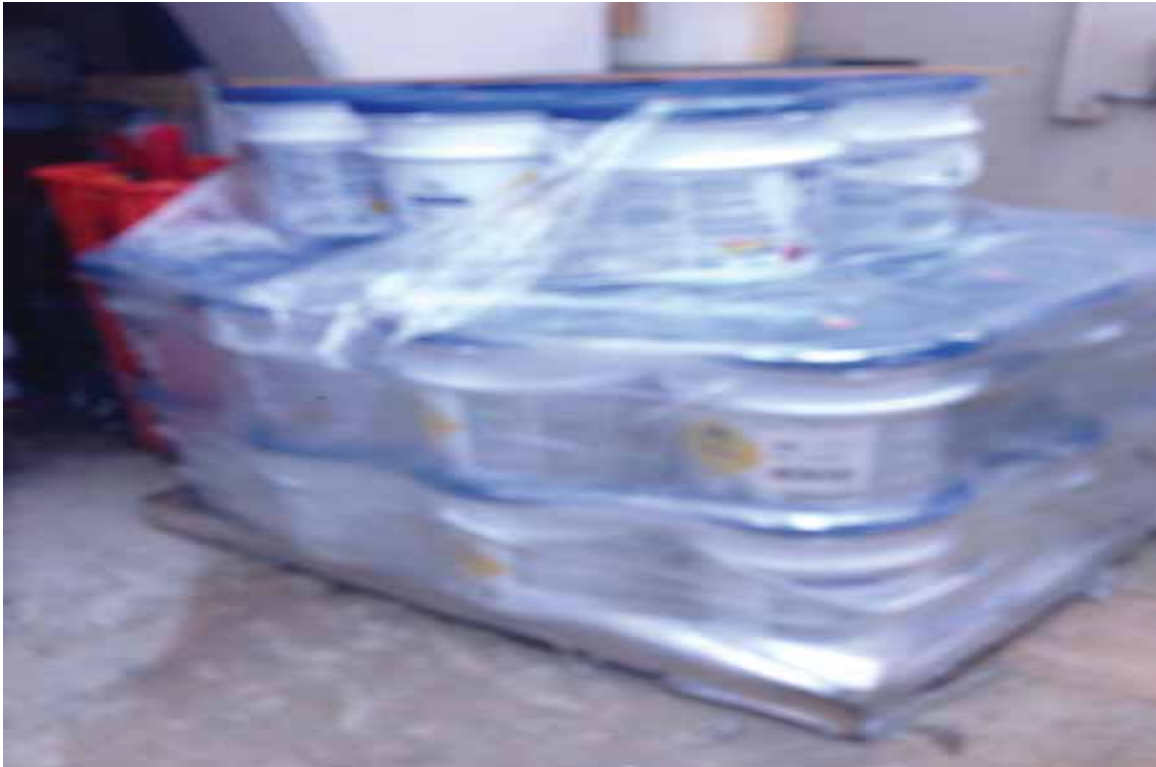
Photograph 4-View of the 5-gallons Hypochlorite observed, building 93

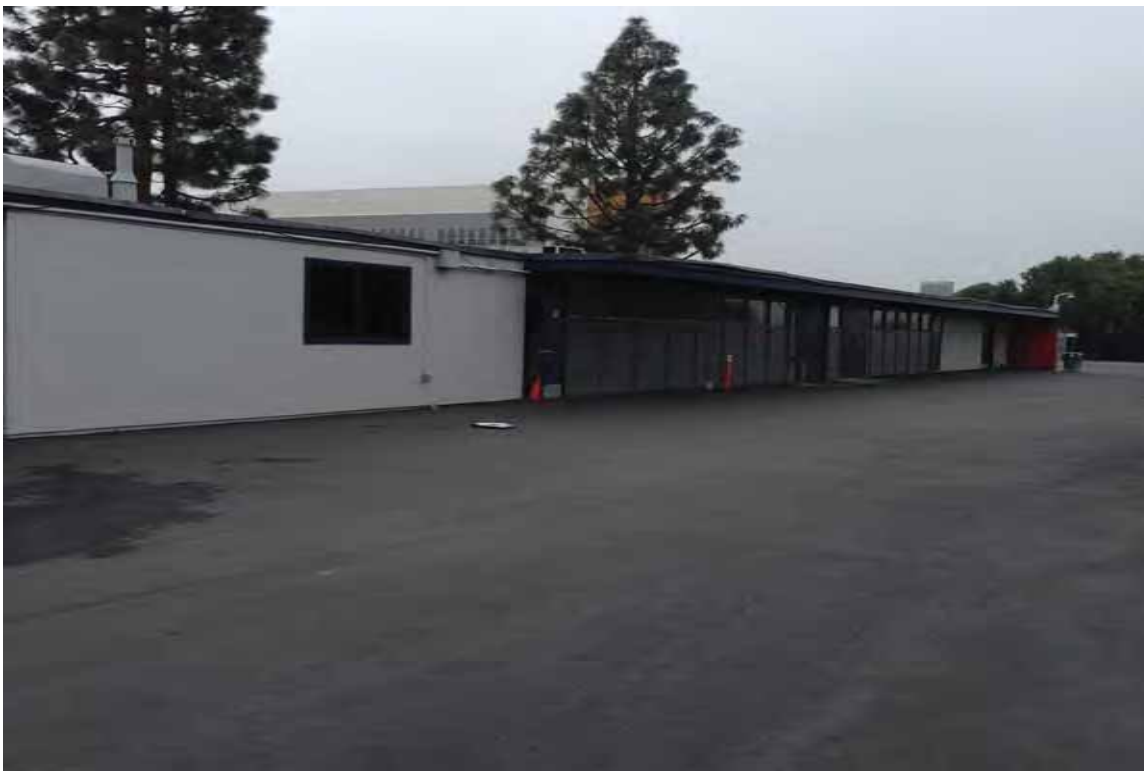
Photograph 5-General view of the suspect roof and exterior building materials, building 110
